NAVAL AIR STATION  
ALAMEDA, CALIFORNIA  
FPO-1-82(20)

**UNDERWATER FACILITIES  
INSPECTIONS  
AND  
ASSESSMENTS  
AT**

**NAVAL AIR STATION  
ALAMEDA, CALIFORNIA**

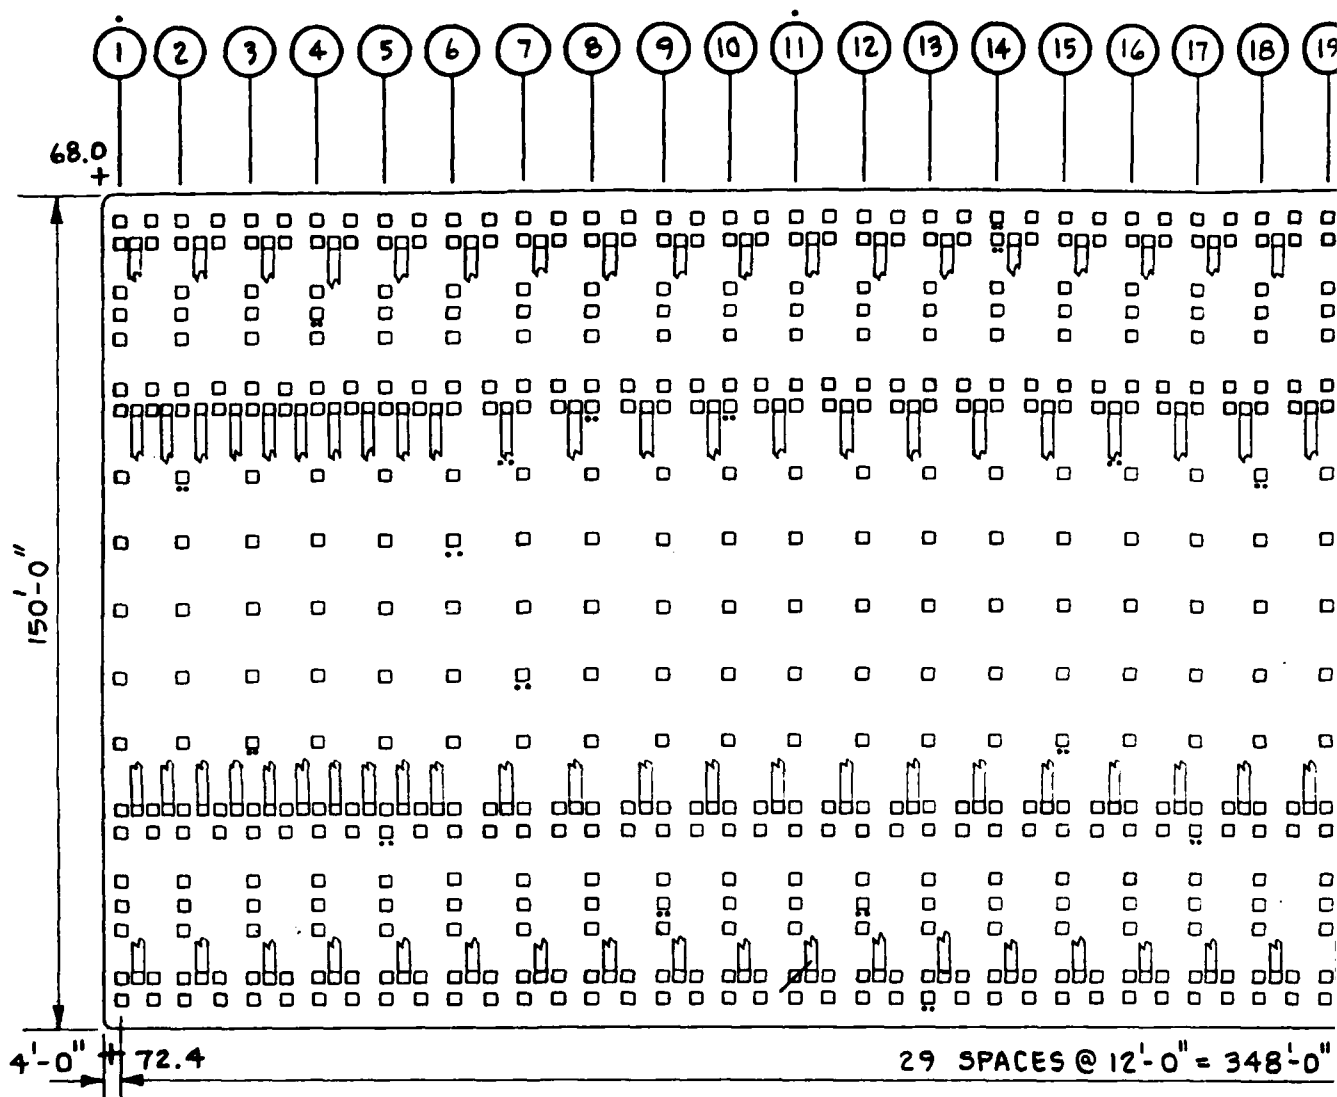
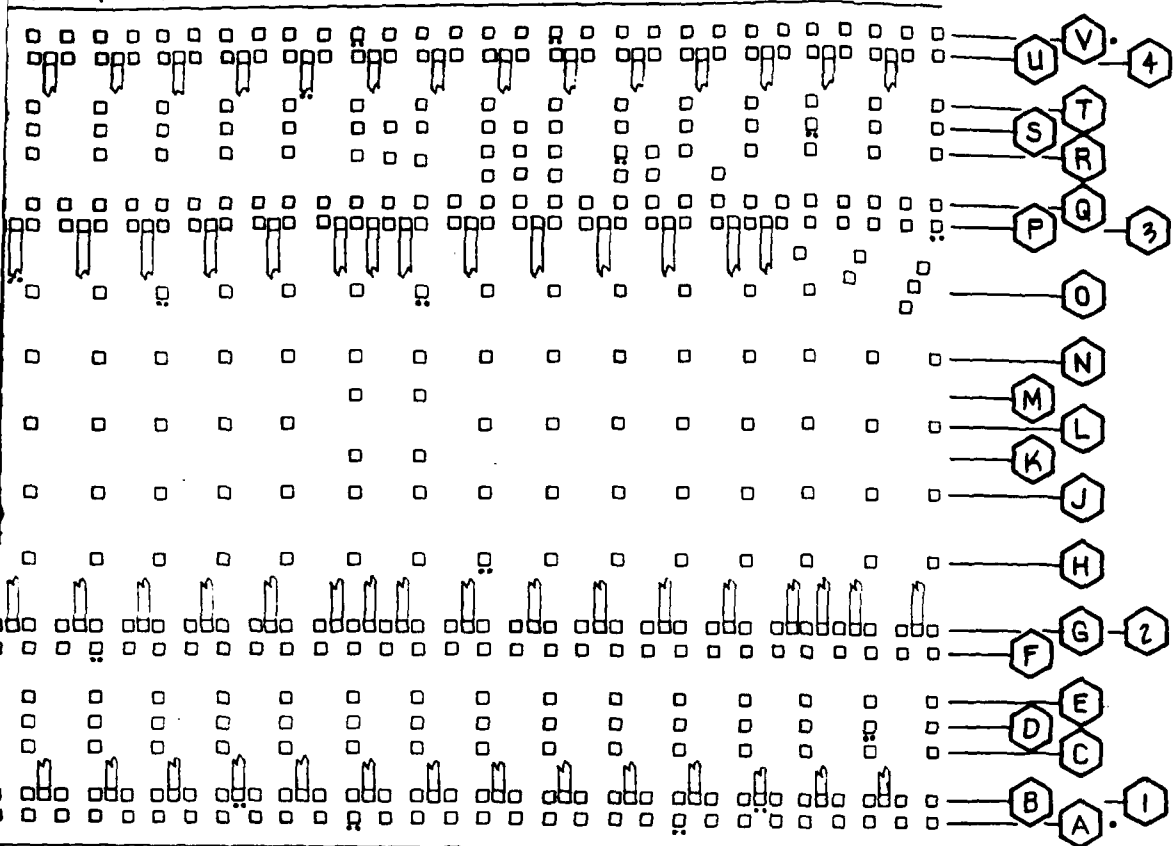
CHESAPEAKE DIVISION NAVAL FACILITIES ENGINEERING COMMAND WASHINGTON, D.C.	
NAVAL AIR STATION	ALAMEDA, CA
PIER #3	FIG. NO. 6

Pier 3 was built in 1945 and is 1355' long by 150' wide. Its reinforced concrete deck is supported by approximately 4,440 20" square precast concrete piles, of which approximately 3,900 are vertical piles and 540 are batter piles (see Figures 6 through 10). The vertical piles are jacketed in concrete from the pile cap down 13'0". The jackets provide a 4" concrete cover on all pile faces. The driven capacity of each pile is 45 tons. The design live load on the deck is 500 psf.

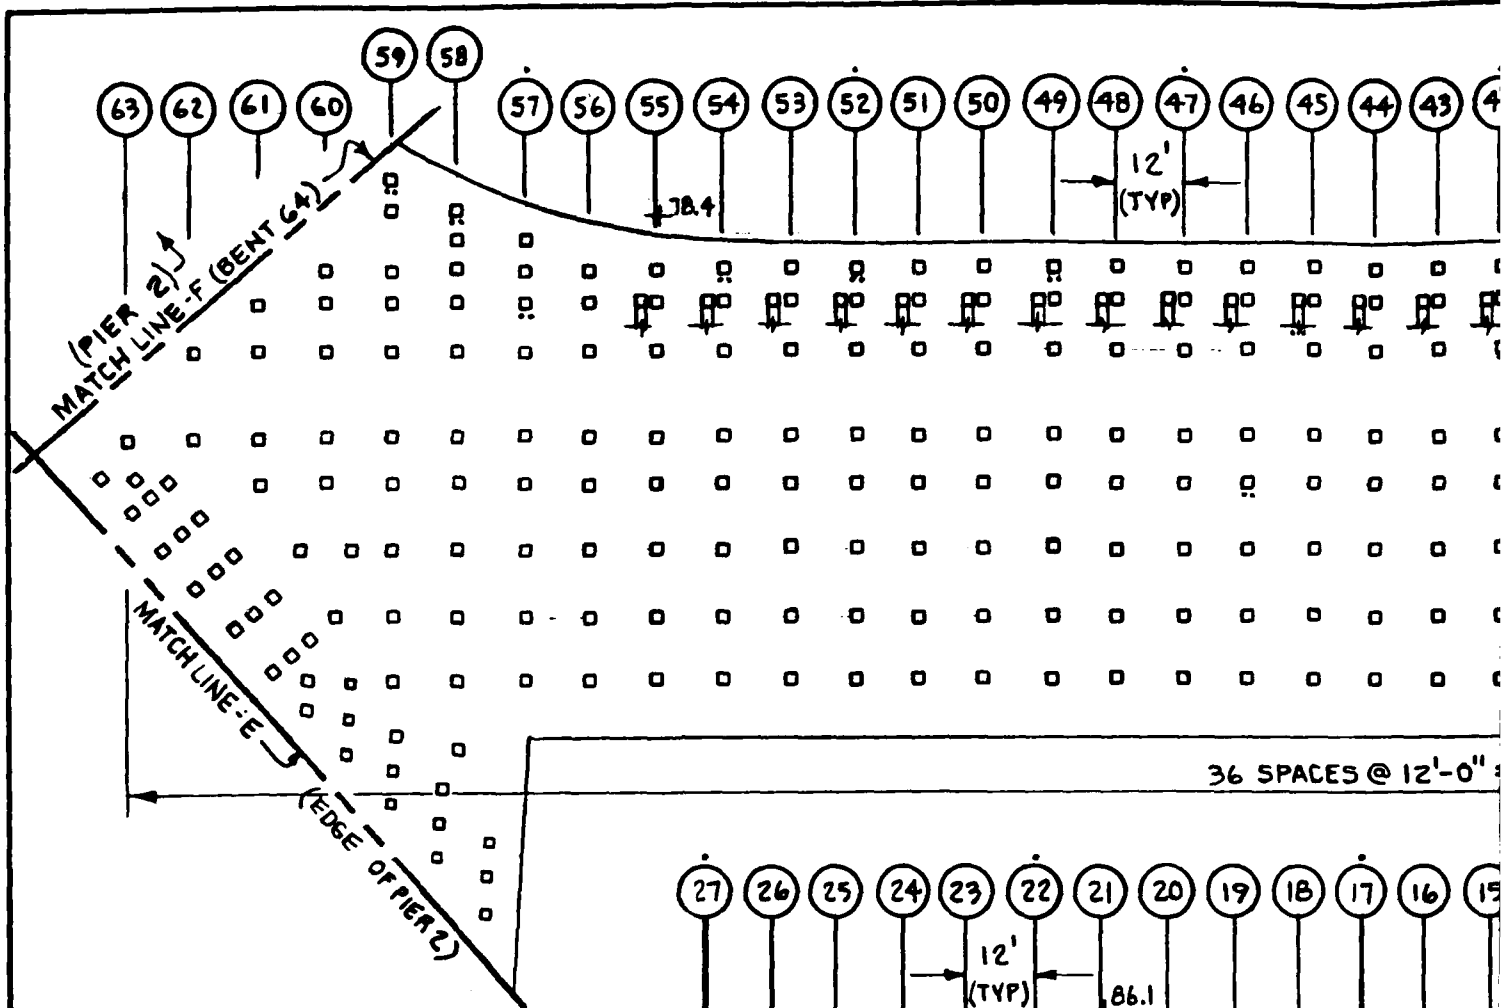
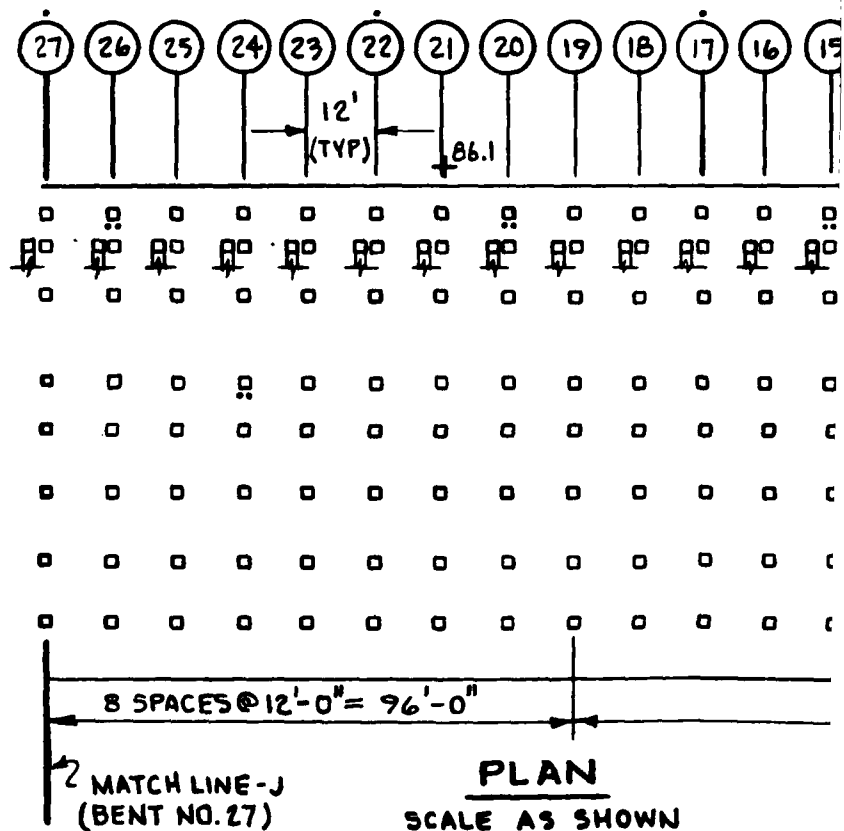
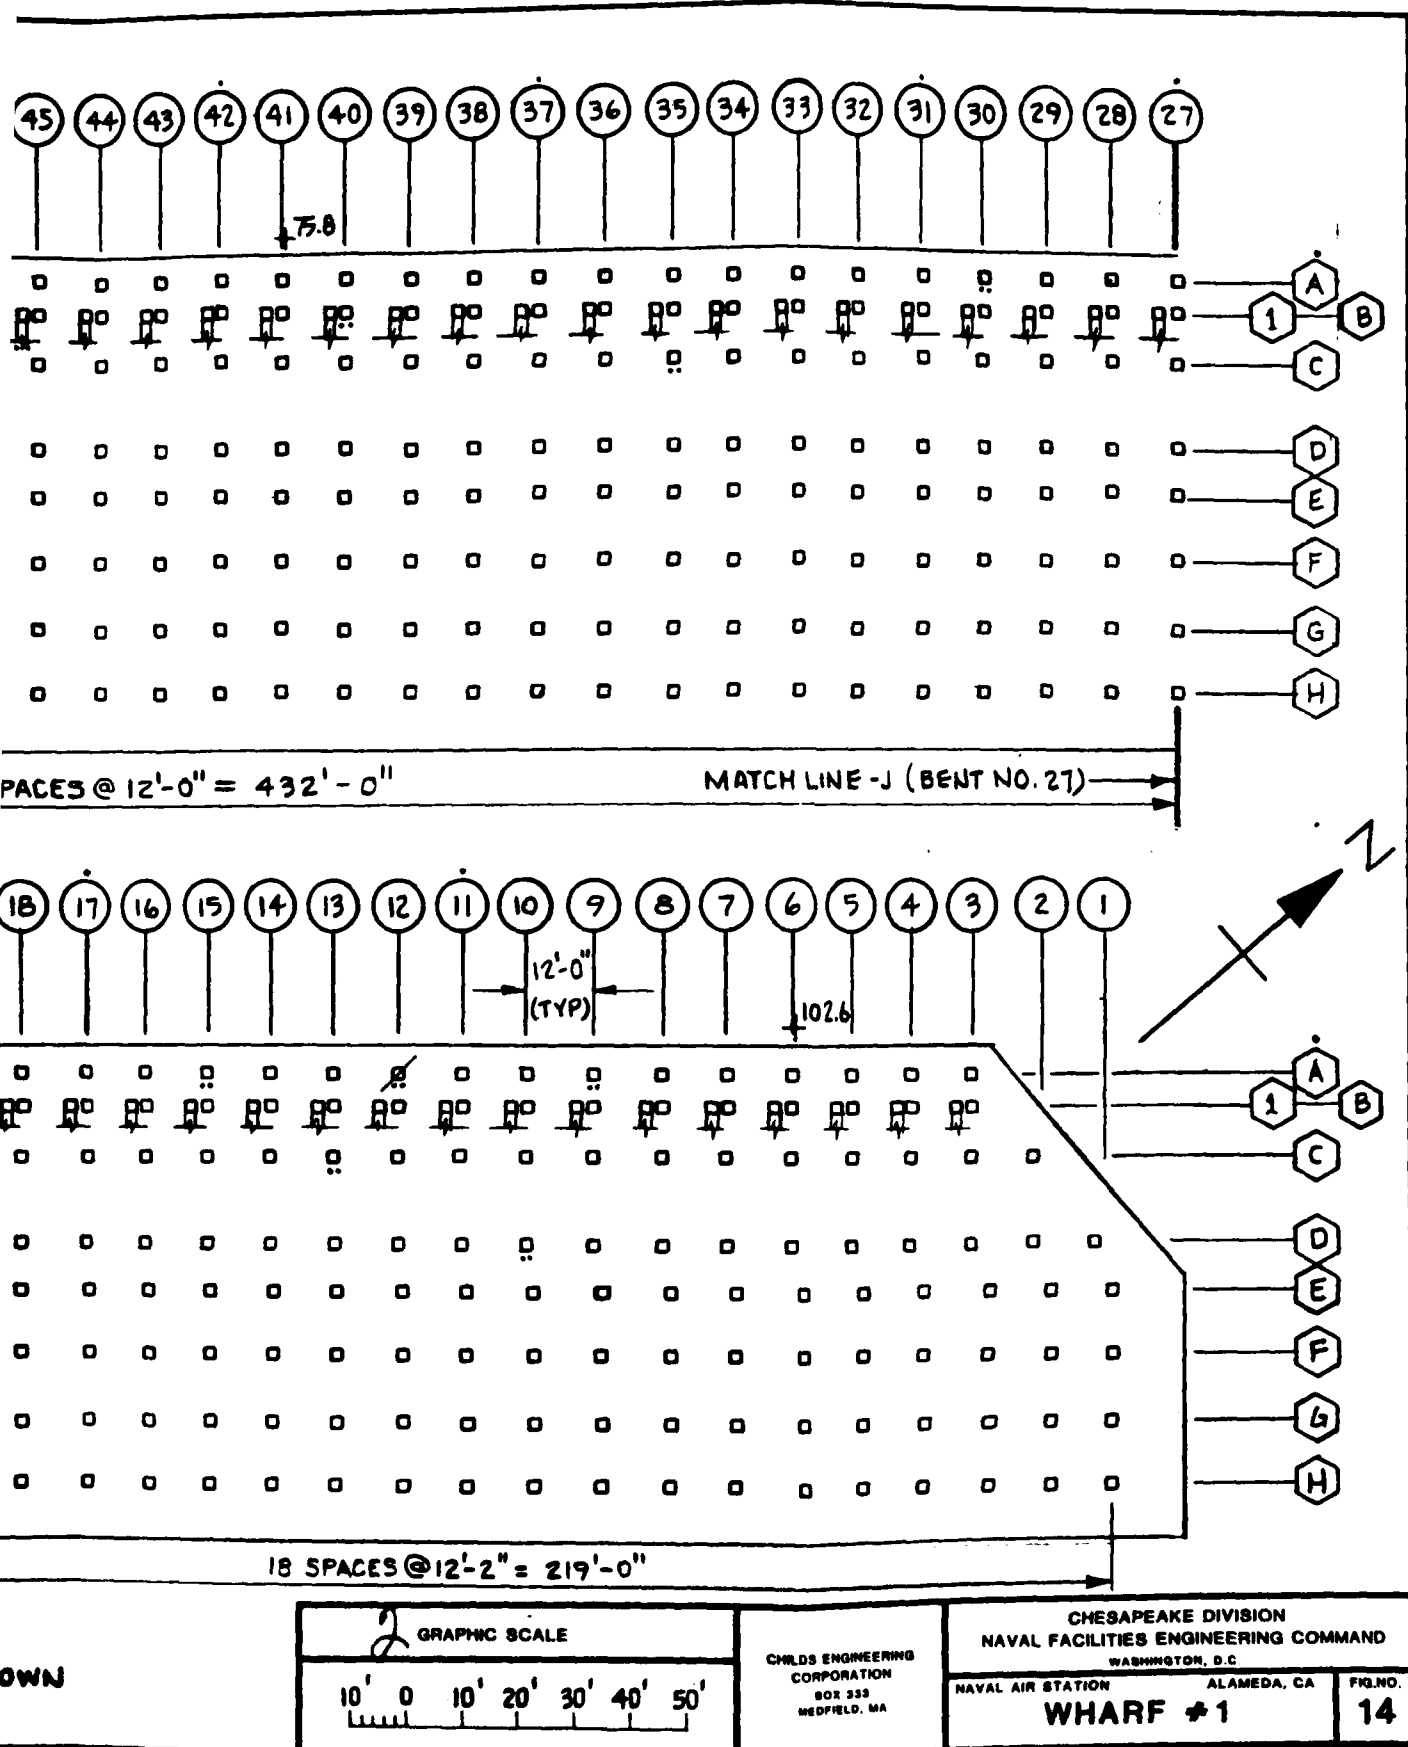
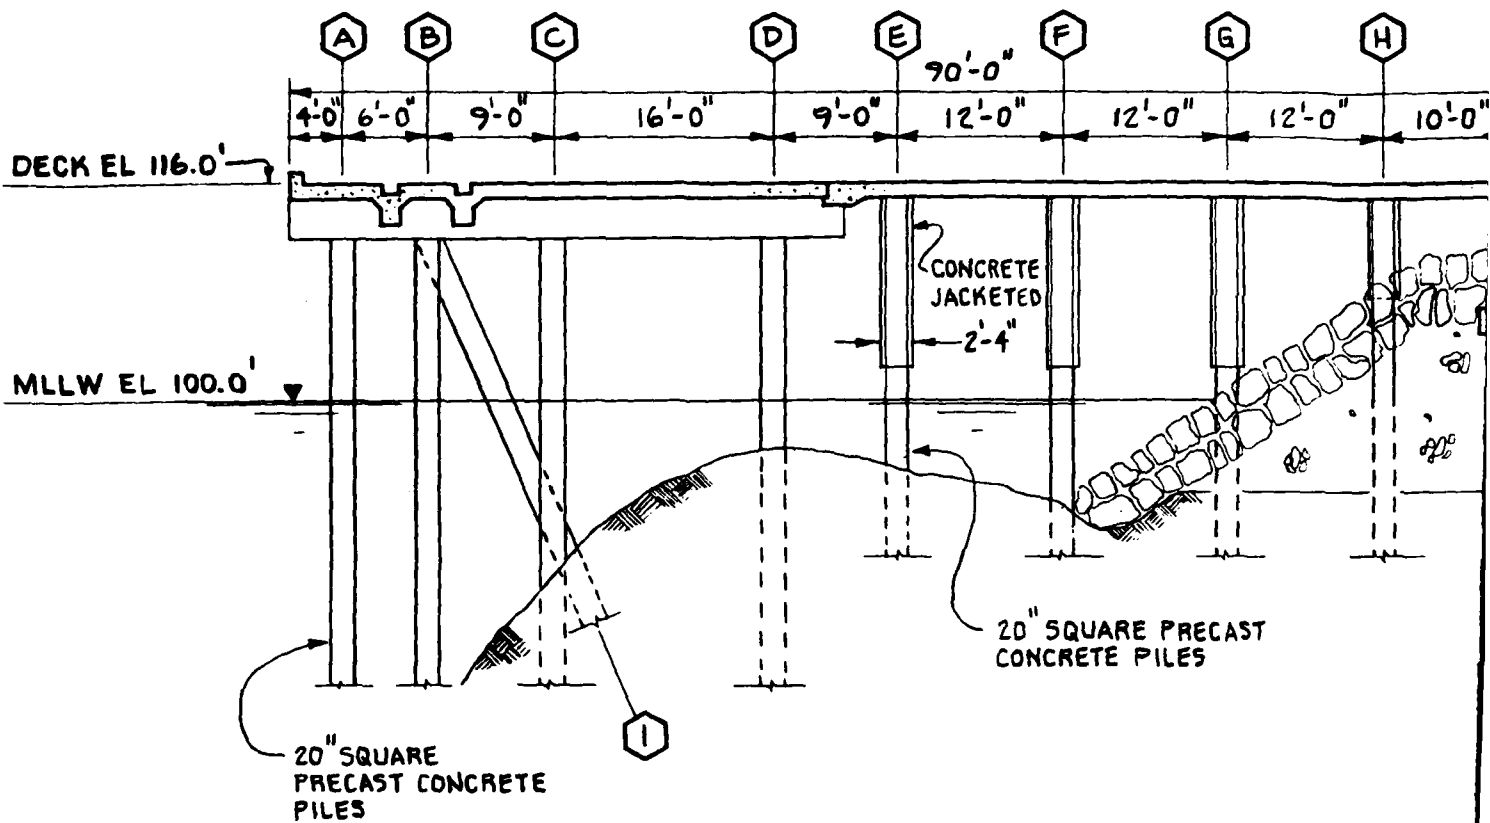
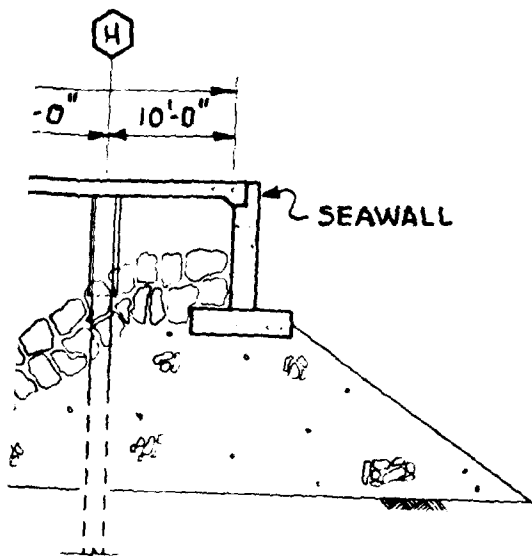
<p>GRAPHIC SCALE</p> <p>10' 5' 0 10' 20'</p>	<p>CHILDS ENGINEERING CORPORATION BOX 333 MEDFIELD, MA</p>	<p>CHESAPEAKE DIVISION NAVAL FACILITIES ENGINEERING COMMAND WASHINGTON, D.C. NAVAL AIR STATION ALAMEDA, CA <b>WHARF #1</b></p>	<p>FIG. NO. <b>15</b></p>
--	--	--	-------------------------------

One of the piles inspected had some minor spalling (see Photo #13). The observed deterioration is cosmetic in nature and is of no real structural significance.

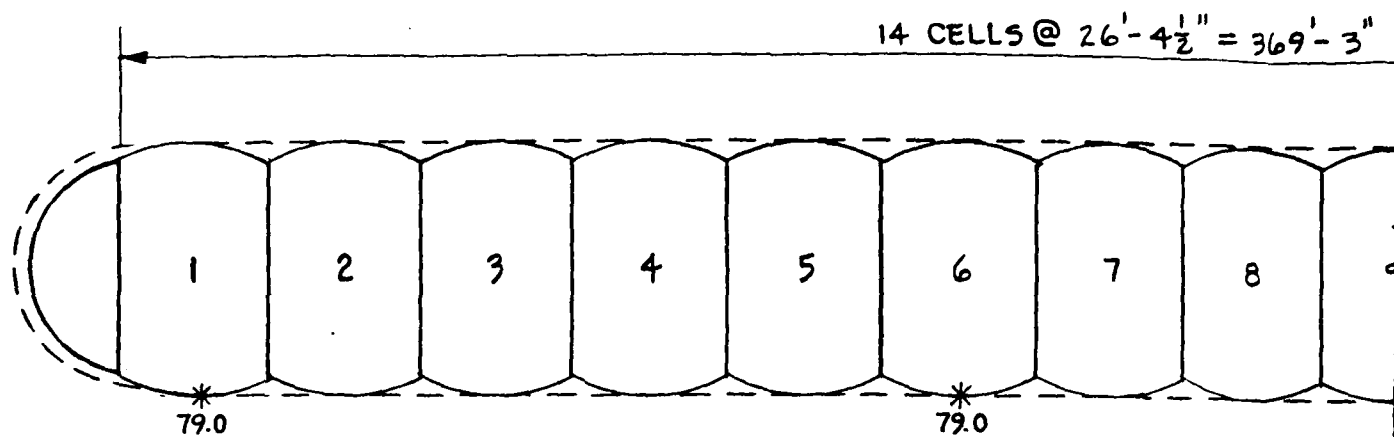
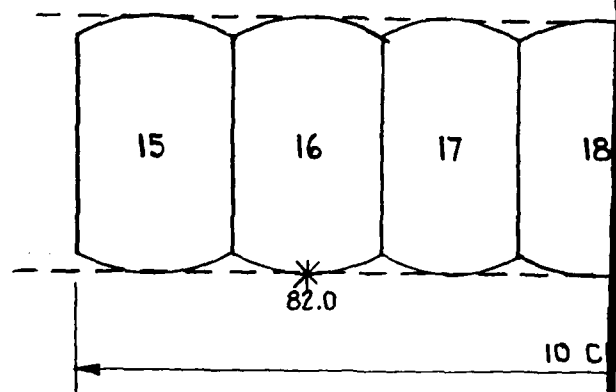
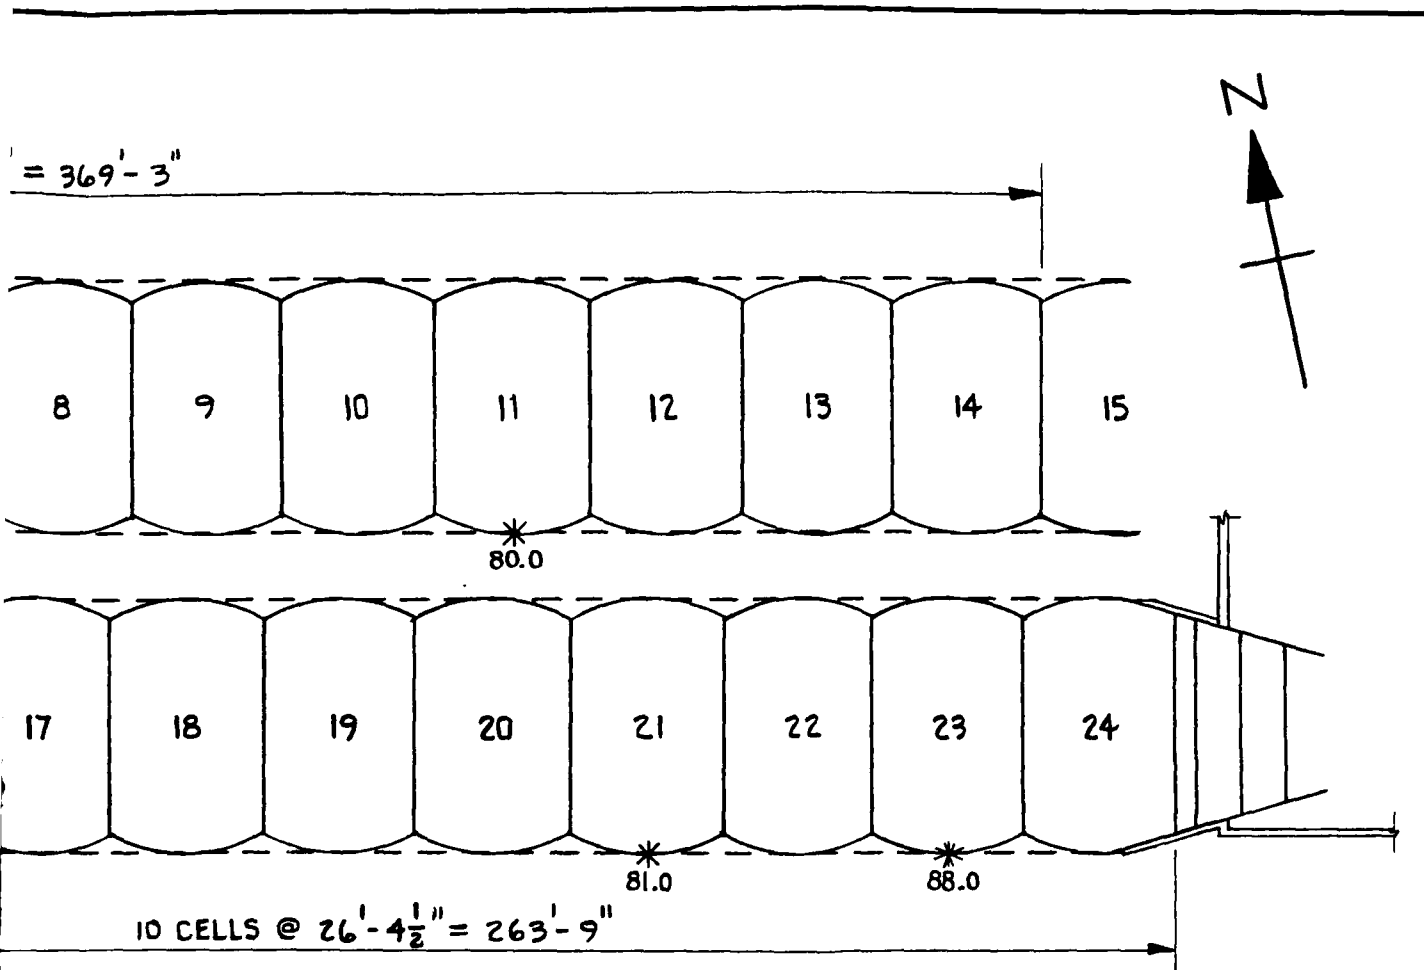
The pier is of an earth-filled cellular-steel sheet pile construction. It was built in 1937 and is approximately 650' long and 50' wide (see Figure 16). The bituminous deck is supported by an earth fill. Live loading on the deck is currently restricted to prevent vehicular traffic.

The steel sheet piling exhibits varying degrees of corrosion from the pile cap to the mudline. Frequently corrosion nodes (see Photo #15) were noted. These nodes are basically corrosion by-product which when removed reveal a significant pit in the steel. The pits ranged in diameter from 1/8" to 5/8" and up to 1/8" deep. Photo #16 illustrates a typical steel sheet pile at the mudline. Other deterioration included corrosion splits at the sheet pile interconnects (knuckles). This condition is not unusual and is the result of corrosion occurring in a high stress area (see Photo #17).

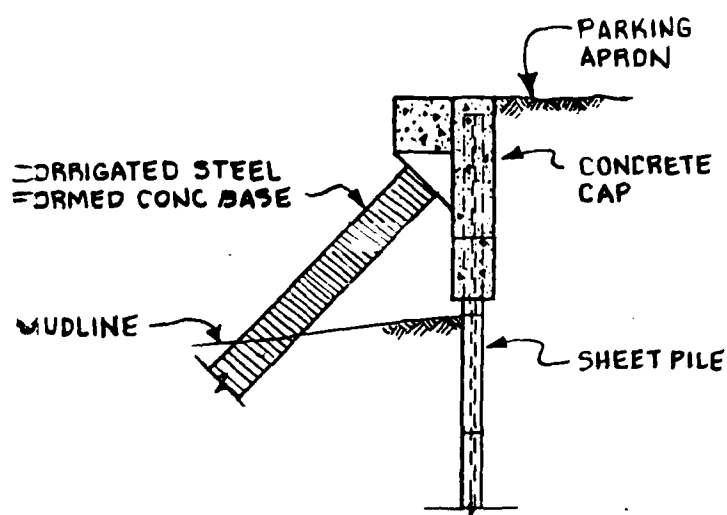
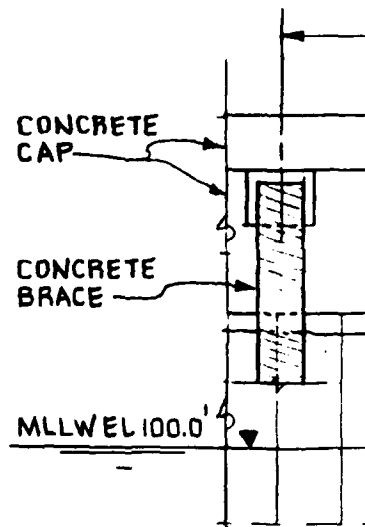
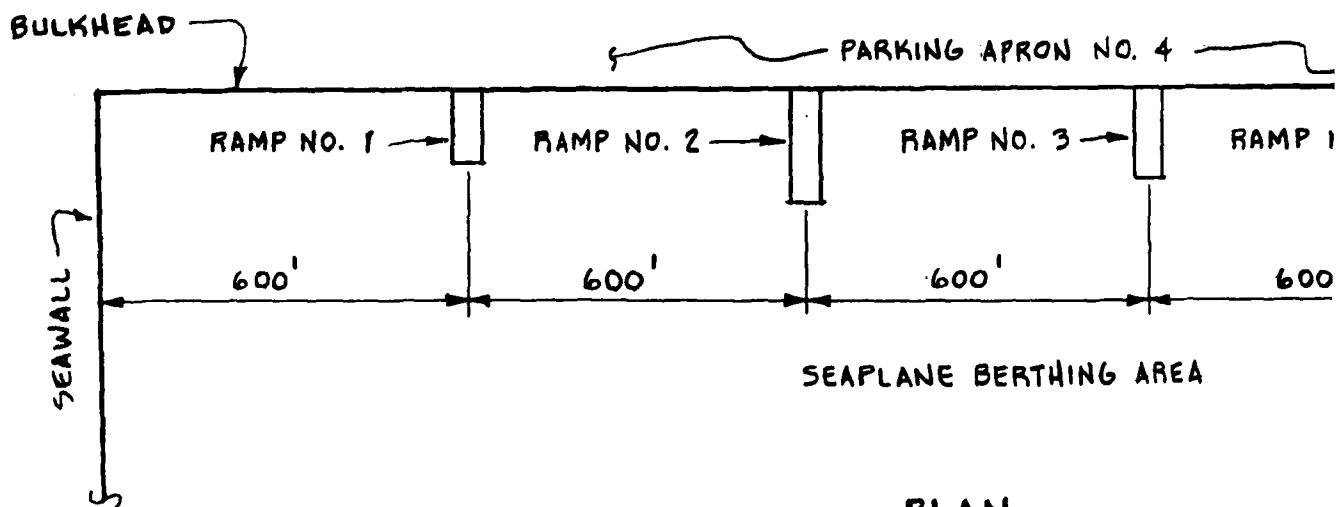
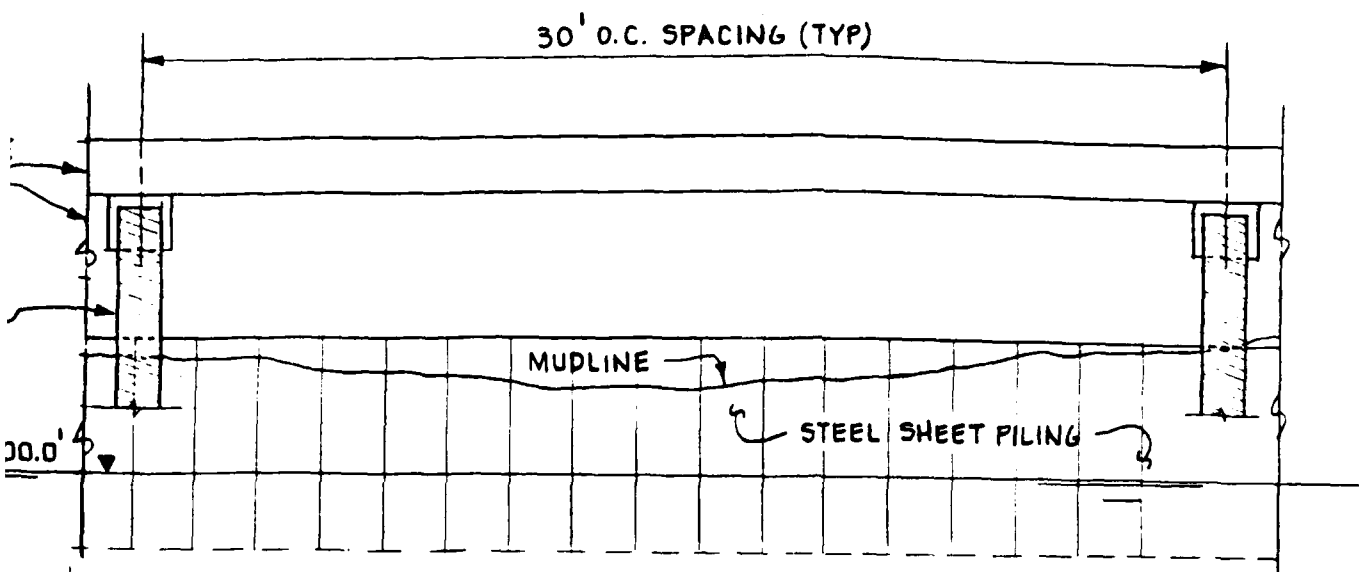
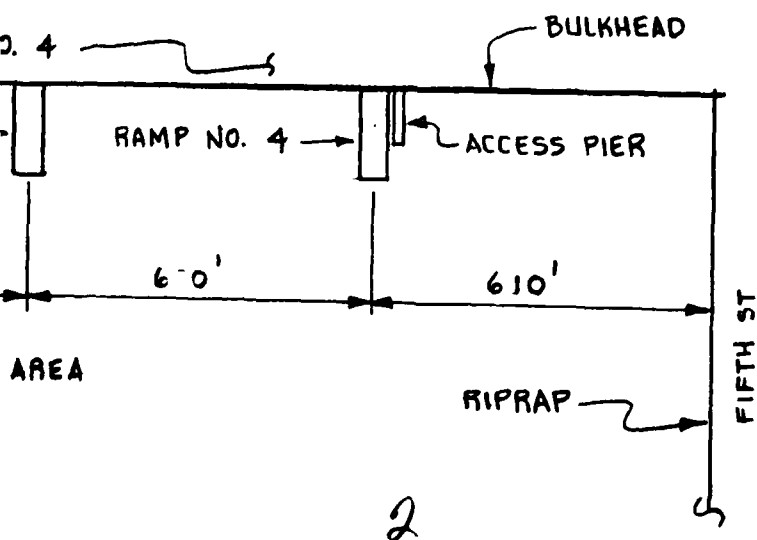
In general, the bulkhead appears to be in good condition. There does not appear to be any significant misalignment along the bulkhead which would indicate yielding of the wall. The concrete encasement around the steel sheet piling is in good condition and shows little sign of deterioration. The encasement concrete is sound.

Thickness measurements of the steel sheet piling indicate metal loss of less than 10%. This is probably attributable to the fact that the original design called for backfilling in front of the sheeting about halfway up the concrete encasement. The fill in front of the wall would have served as a barrier against corrosion. At present, there are several locations (approximately 50% of the length) along the wall where the steel sheeting is exposed. Maximum exposure is approximately 2 feet (see Photo #18).

The batter piles are corrugated steel shells filled with concrete. The condition of the shells is poor since much of the metal is corroded, however, the concrete within the shells appears sound.

The wall cap extension which is used to tie in the batter piles is in fair condition. The upper and lower edges of the concrete have spalled in many locations. In some instances, rebar is exposed in the spall areas and is corroded.

The bulkhead is in good condition. No major structural anomalies were found which would detract from its capacity.

The deterioration of the concrete wall cap should be stopped to prevent weakening of the batter pile system.

The spalled corners of the concrete wall cap should be repaired by cleaning to sound concrete, cleaning and/or replacing deteriorated rebar and patching with pneumatically applied concrete. This will prevent deterioration of the batter pile support system.

Fill should be placed in front of the wall to original design levels. This will eliminate corrosion of the steel sheet pilings.

The estimated cost of repairing the wall cap is \$18,000.00 and filling in front of the wall is \$43,000.00.

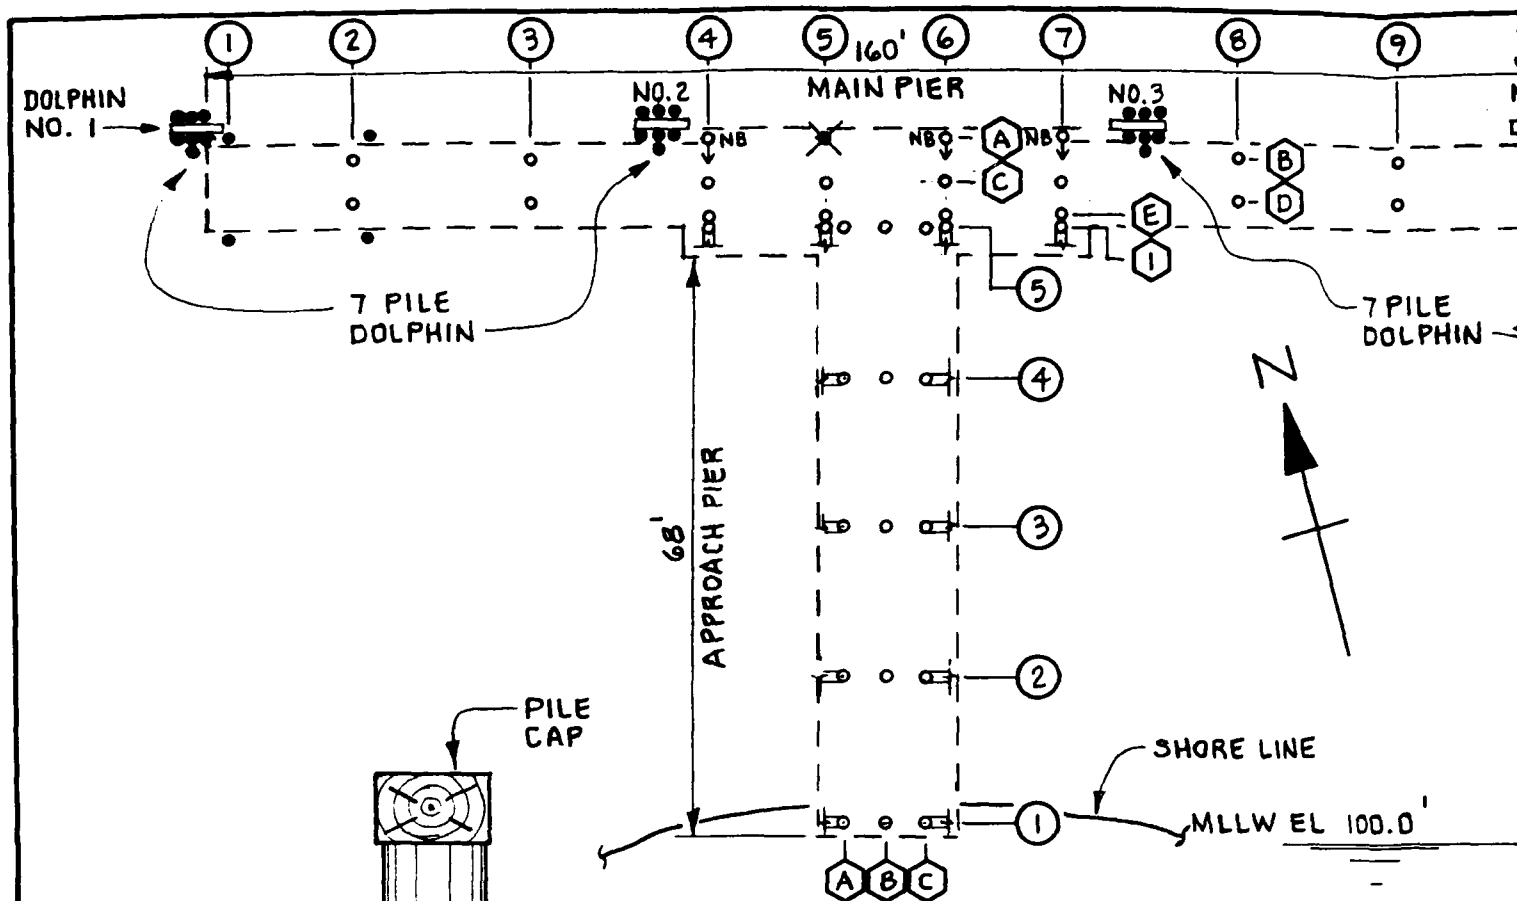
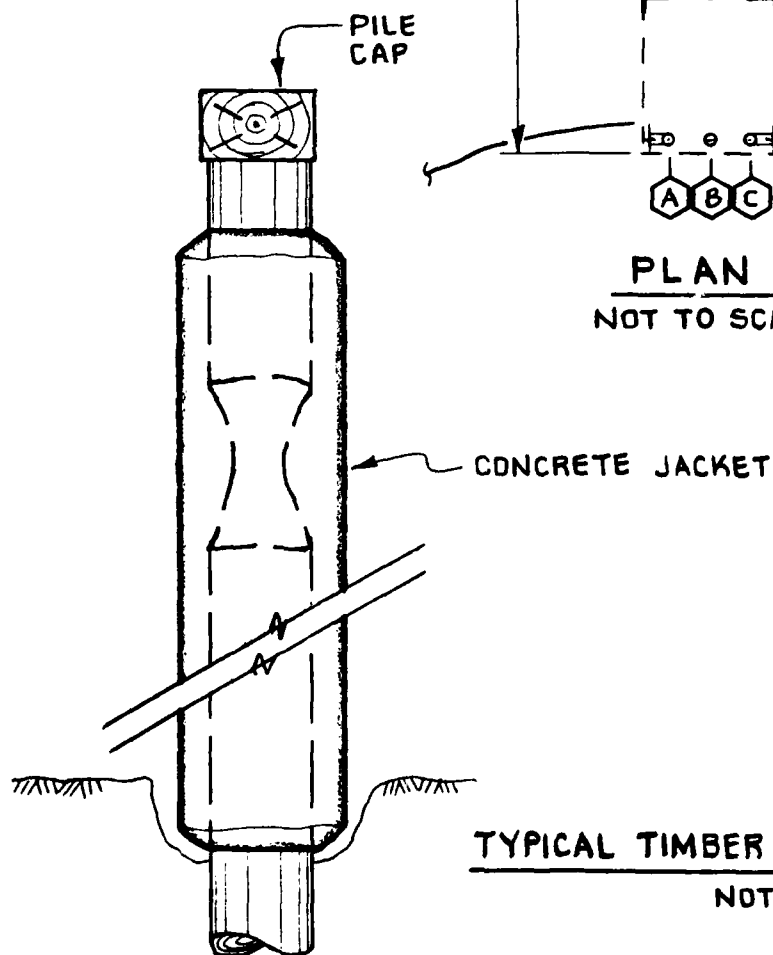
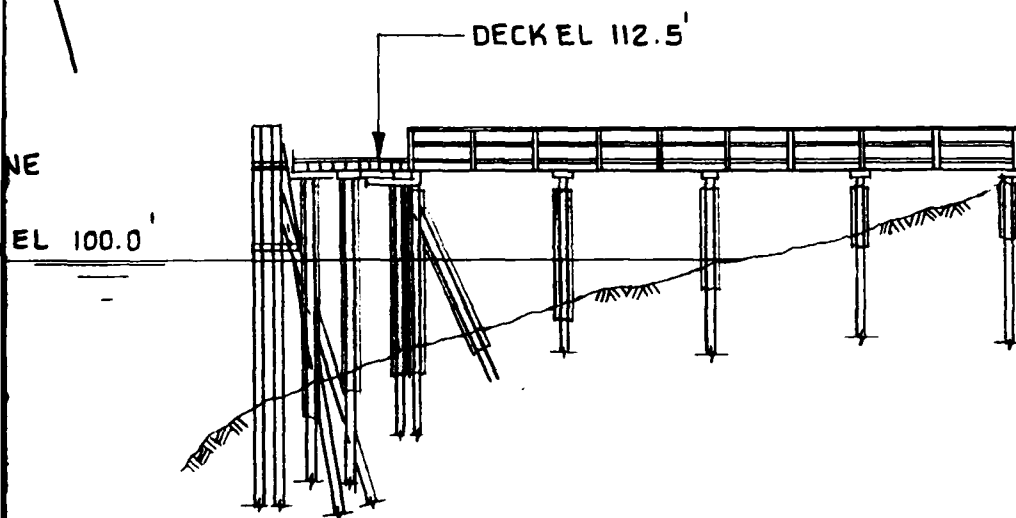
**PLAN**  
NOT TO SCALE

In general the piles are in good condition.

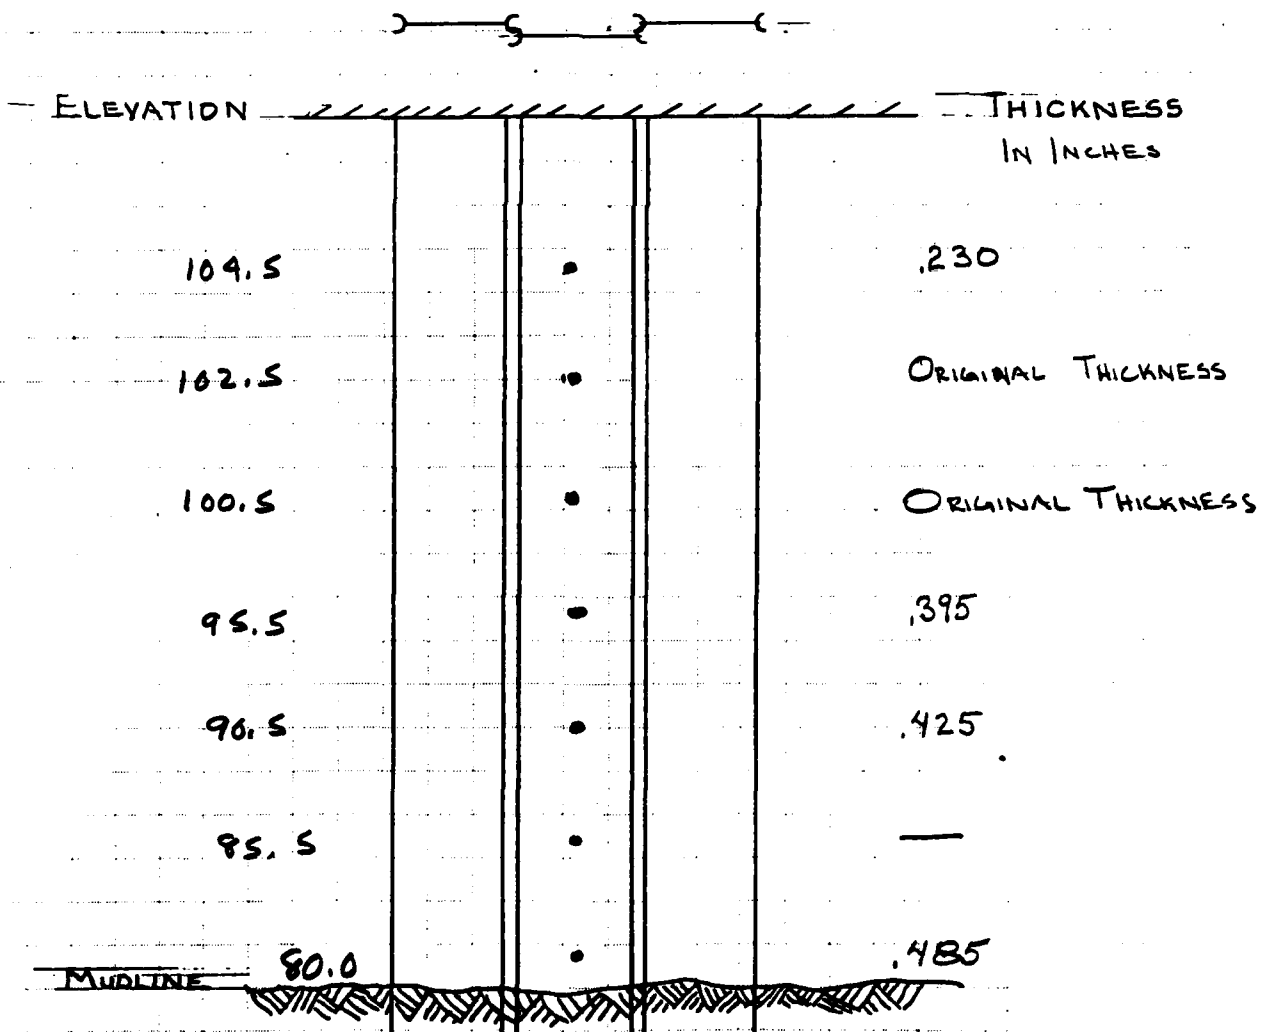
STATION CELL 11 SOUTH

ORIGINAL THICKNESS: .500"

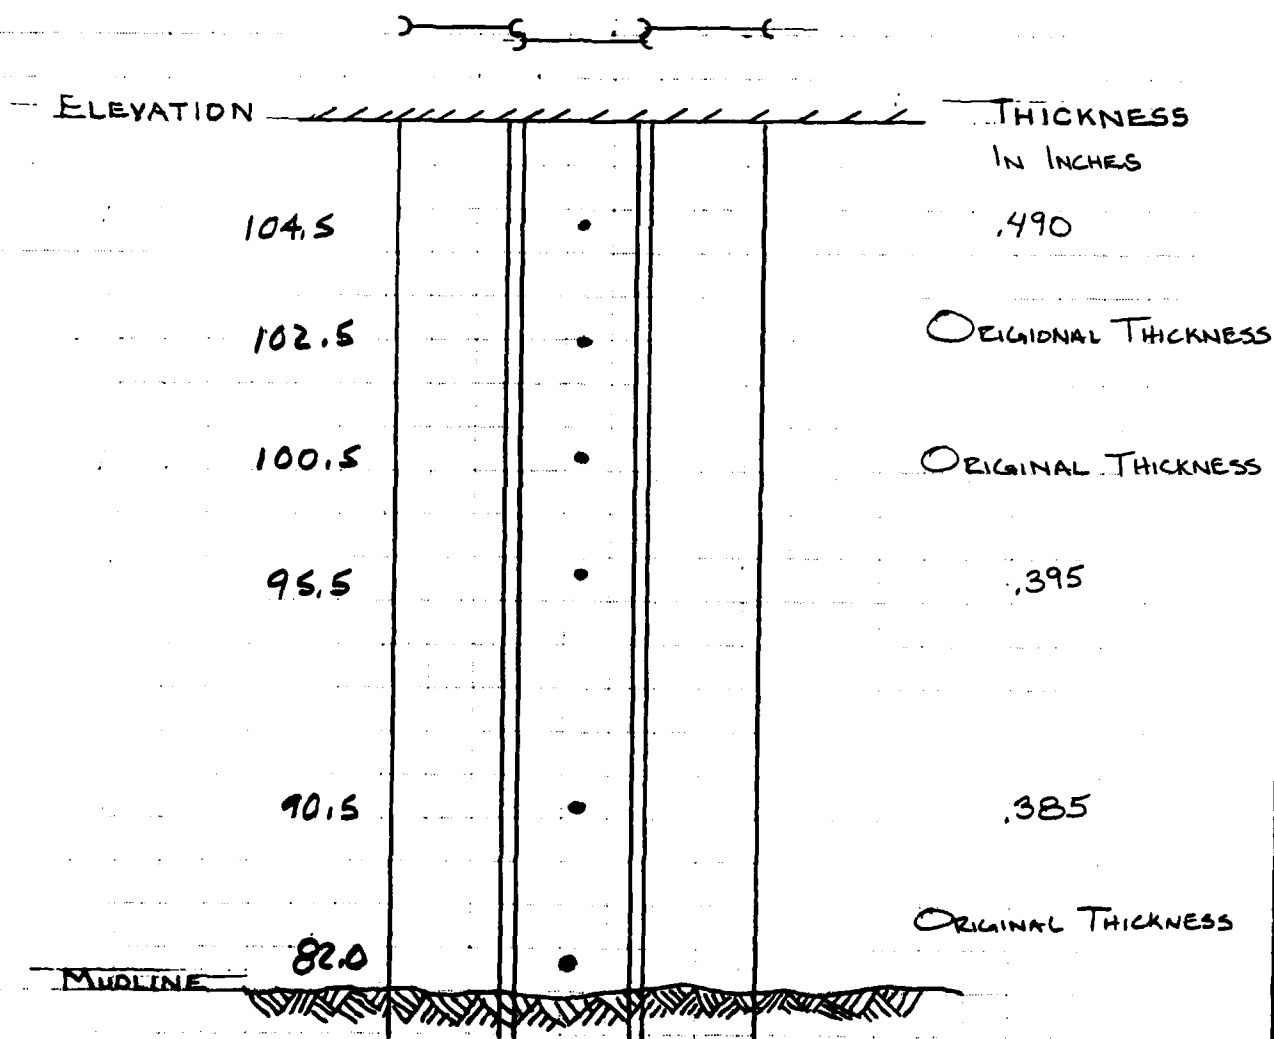
FACILITY PIER 1  
STATION CELL 16 SOUTH

ORIGINAL THICKNESS: .500"

ELEVATION	THICKNESS IN INCHES
104.5	.490
102.5	ORIGINAL THICKNESS
100.5	ORIGINAL THICKNESS
95.5	.395
90.5	.385
82.0	ORIGINAL THICKNESS

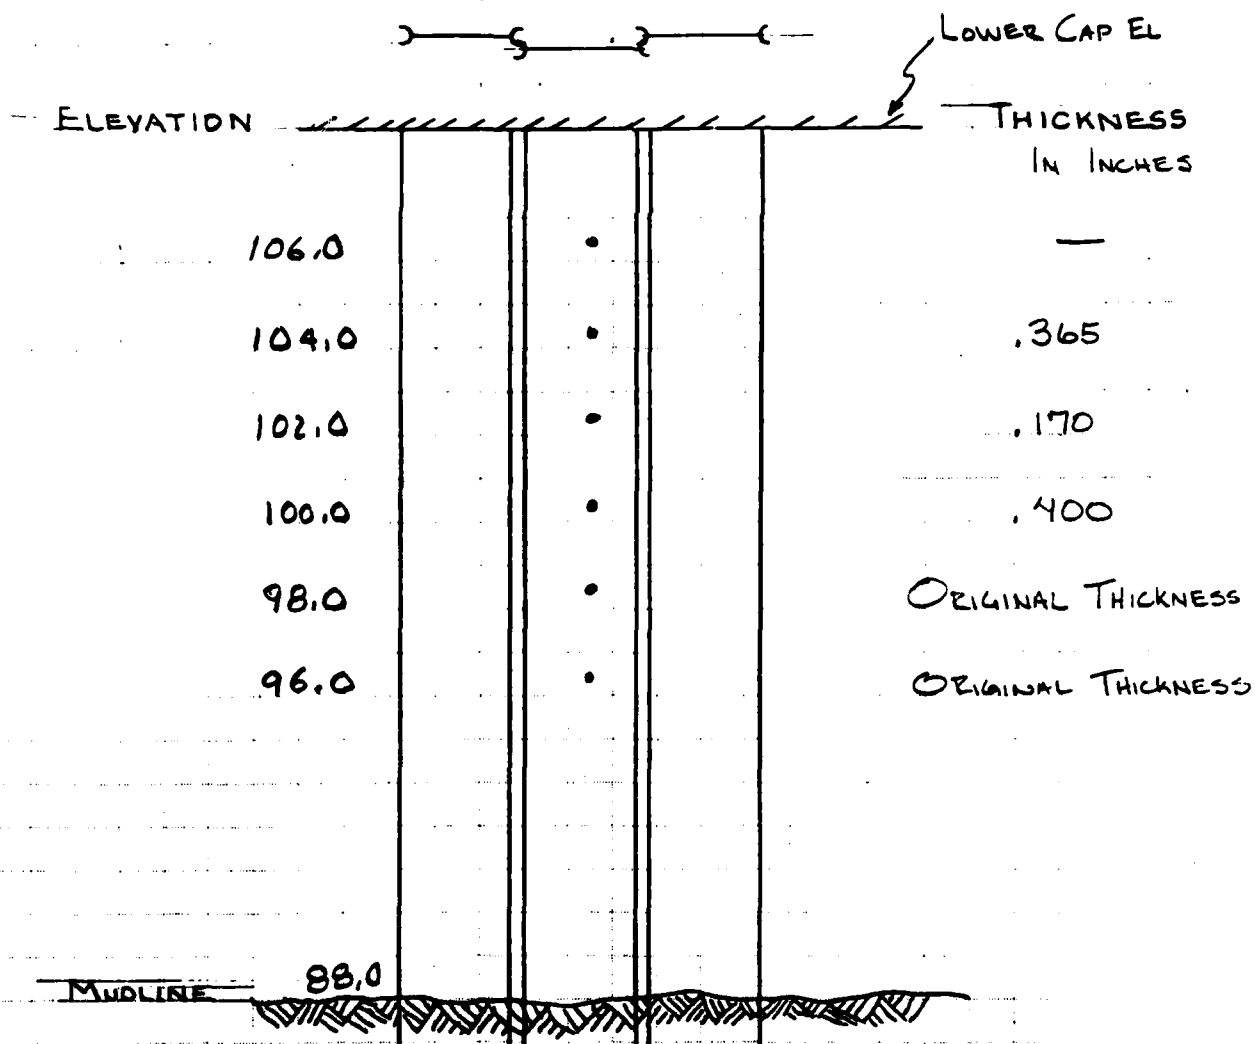
FACILITY PIER 1  
STATION CELL 23 SOUTH

ORIGINAL THICKNESS: .500"
